Case History 7 -PAD in Caries

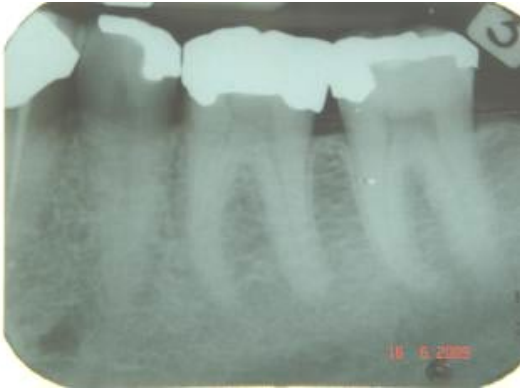
1. 35, 36 and 37 showing large amalgam restoration in 37 with caries beneath the amalgam (mesially)

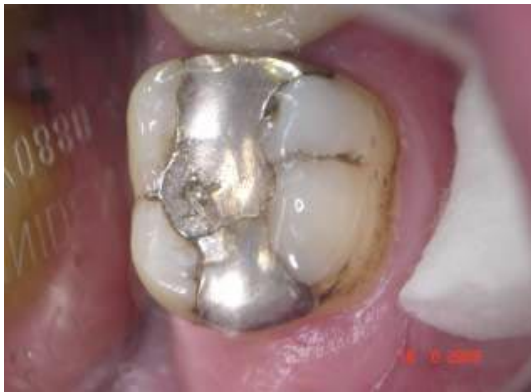
2. Restoration in 37 prior to removal. Note: crack across the occlusal surface and amalgam showing signs of creep

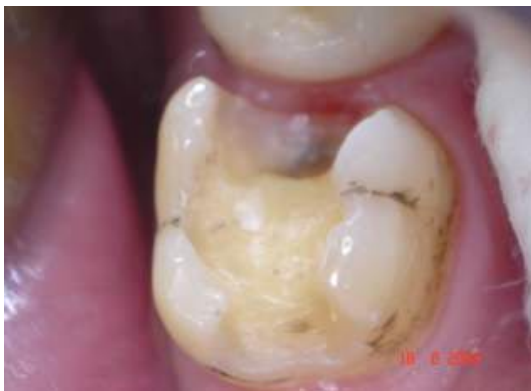
3. Cavity after amalgam removal and cavity completion. Note extension of the cavity medially and deep mesial box

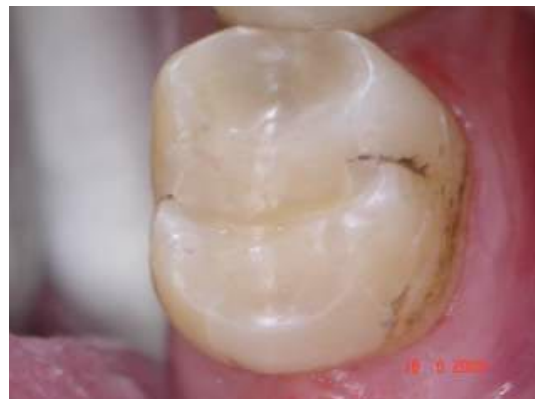
6. 37 with the final restoration in place. Note that there is no discolouration of the aesthetic restorative.
